LD90S Rain Test Report

Data: 2013-08-12

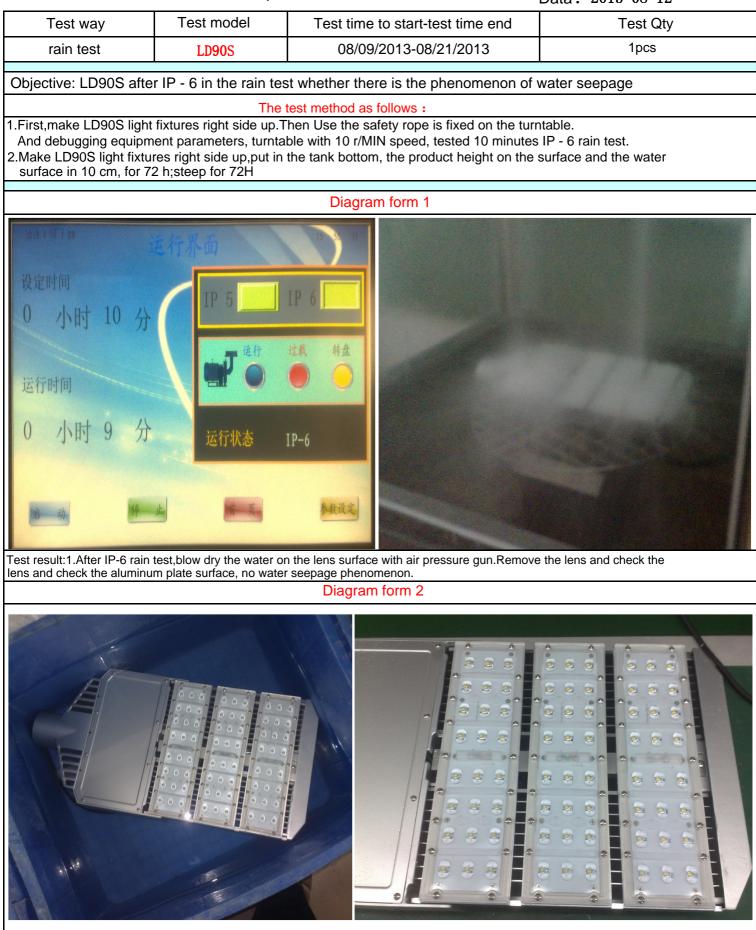
Test result:1.After steep 72H, blow dry the water on the lens surface with air pressure gun.Remove the lens and check the aluminum plate surface, no water seepage phenomenon.Light up the test, led light source are luminous normally.
